## Sprinter anti-roll bar drop link replacement tip (T1N)

## Mercedes Sprinter Heater Blower Motor Brush Replacement

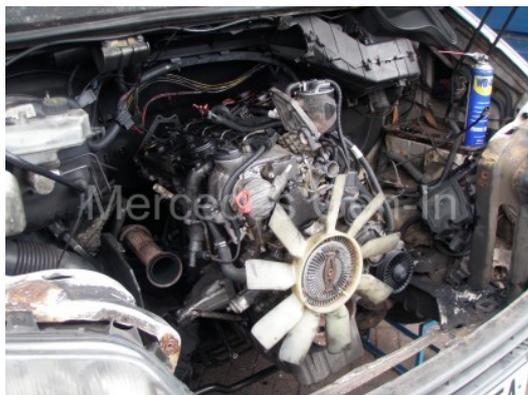
run up the newly installed lump, I will change the seal and overhaul this part of the engine before continuing to fully build up the unit. Its easier to remove an injector from an engine mounted in a vehicle than to try and chase it round the garage, especially if attempting to remove a difficult or stubborn injector.

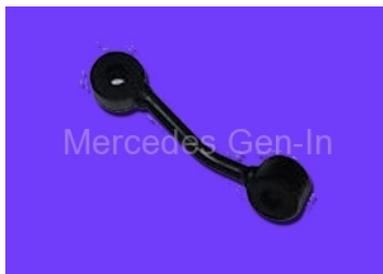
### Drop Link Sprinter

Here is a quick tip I have used to assist in replacing the anti roll bar links on the Mercedes Sprinter 2000-2006 model year T1N. Often due to corrosion of the smooth surface that used to be the painted ends of the anti-roll bar (sway bar) and the wishbone attachment makes for difficult removal and refitting of the drop link arm bushes.

Remove the triangular plate that covers the end of the leaf spring 3x 16mm bolts. Take the plate with the integral lower mounting bar from the vehicle and use a vice or large clamp to press the bush onto the mounting stake. Use some spray lube as above to assist fitting. Refit the leaf spring cover plate to the lower wishbone and remove any loose rust scale from the roll bar end. Offer up the unattached drop link arm bush to the end of the roll bar (use a little lubricant on the rubber again) Take a 22mm 1/2 drive socket and

place it over the end of the drop link bush/arm to be pushed onto the roll bar. Have an assistant turn the van steering wheel slowly either left or right lock dependant which side you are working. Position and trap the socket between the back of the hub assembly and drop link bush as the lock is applied. Continue to turn the steering wheel to further push the socket and as a result press the bush with minimum effort onto the end of the roll bar. Job done...!

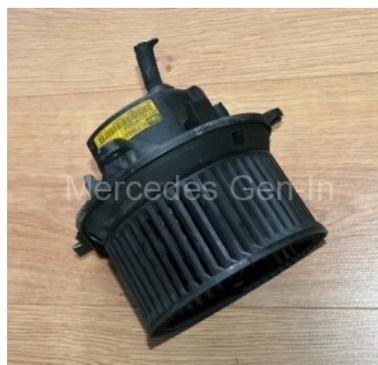
Intermittent or no rotation of the heater blower fan is a common problem on the Mercedes Sprinter.

On the Sprinter, start by unplugging the electrical connector from the base of the fan assembly in the passenger side engine compartment. Remove the 3 cross head self tapping screws that hold the fan/motor assembly to the blower box then withdraw it downward, removing the unit out from the vehicle. Placing the unit on the floor or
